Robotic Inspection of Unpiggable Piping at Pump Station

by Steve Lacatena¹ and Jonathan Minder²

Unpiggable Pipeline Solutions Forum

12-13 May, 2015

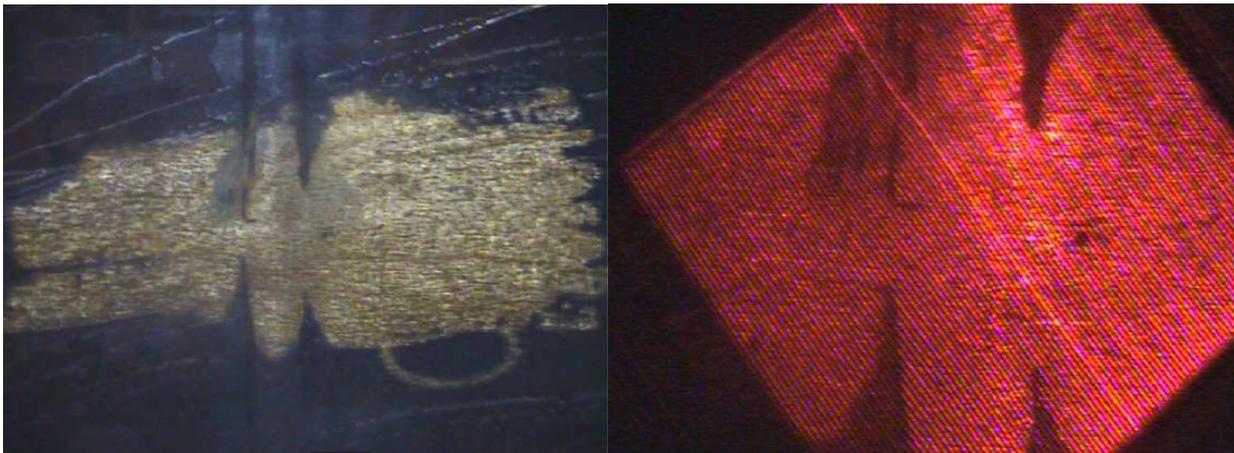
Laser profilometry scans were also taken at locations where anomalies were detected during the initial visual inspection of the pipe. Only a few anomalies were detected during visual inspection of the pipeline, but each of them had minimal wall loss of 0.09” or less. Figure shows an example picture and corresponding laser profilometry scan of an anomaly found in the discharge relief line.

Figure 4: Photograph and Laser Profilometry Scan of Anomaly Found in Route 4b 70.2 Feet
