Online Storage Tank Floor Inspection Services

- API 653 tank floor inspection service for filled tanks
- Eliminate unnecessary tank turnarounds
- Complete coverage analyzed in real time
- Certified explosion-proof to Class 1, Div 1

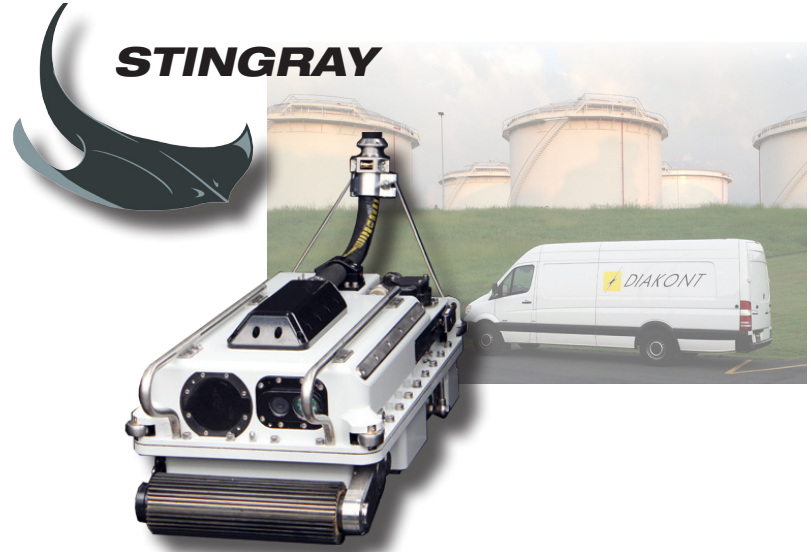
Diakont's Stingray inspection systems are equipped with multiple NDE sensors to assess the actual integrity of storage tank floors.

- Magnetic flux leakage (MFL) – High resolution sensors for detecting anomalies
- Ultrasonic testing (UT) - High accuracy sensors for collecting floor thickness measurements and sizing anomalies
- 3D sonar imaging - XYZ scans of tank floor and internals for mapping and navigation

Stingray inspection systems are equipped with water jets and power scrubbers to clear tank floor sludge and sediment, allowing the onboard magnetic flux leakage (MFL) and an array of ultrasonic testing (UT) sensors to capture high accuracy integrity data. Stingray systems are also equipped with advanced navigation modules that use 3D sonar imaging for mapping their location within the tank.

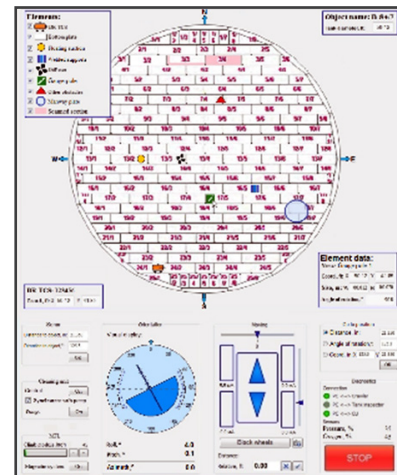
Complete tank floor map generated in real-time
