Robot looks for hidden pipeline damage

Alyeska uses a state-of-the-art 'robotic crawler' to inspect buried pipeline at pump station 3 on the trans-Alaska oil pipeline

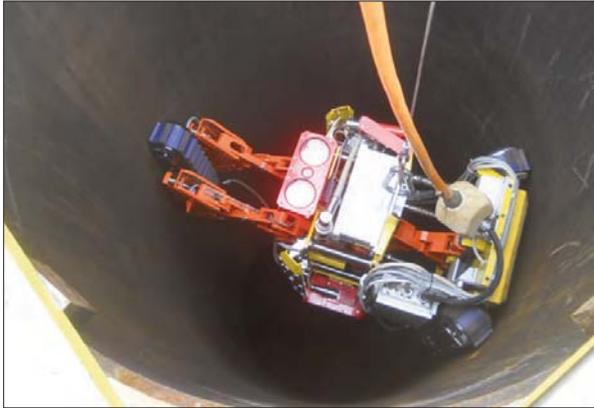
A robotic crawler device can negotiate a vertical pipeline section by pushing its caterpillar tracks against the pipeline walls, here in one of Alyeska Pipeline Service Co.'s 36-inch lines. The device can adjust its tracks to fit a range of pipeline diameters.

Steve Lacatena, Alyeska facility corrosion integrity manager, told Petroleum News that the Diakont robotic crawler has three caterpillar tracks, two at the bottom of the device, acting rather like the tracks of a conventional tracked vehicle, and the third on the top of the device. As necessary, that third track can be extended out, to push against the inside of the pipeline wall, holding the crawler rigidly in place in, say, a vertical pipeline section. The device can travel through about 1,000 feet of pipeline, negotiating up to four right-angle elbows. And, given the manner in which that upper track can be extended or contracted, the device can traverse pipelines with a wide range of diameters, including the large 36-inch and 48-inch lines that Alyeska uses.

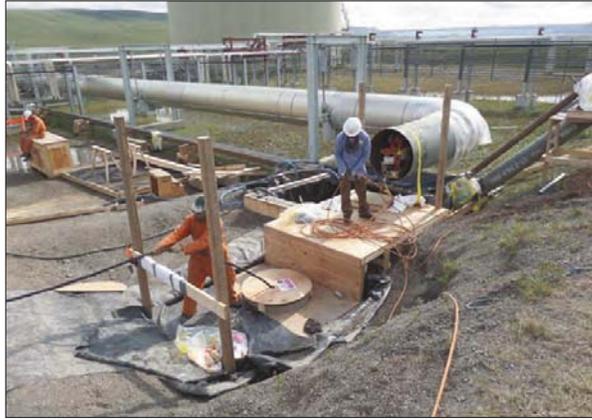
An operator lays out the umbilical control cable for a robotic crawler after the device has been inserted into a pipeline section.
